Manhole Inspection Summary

Manhole # S11GG2010MH

Insp Date: **7/7/06 3:39 PM**

Location Address: **2320 BRIGHT LEAF WAY**

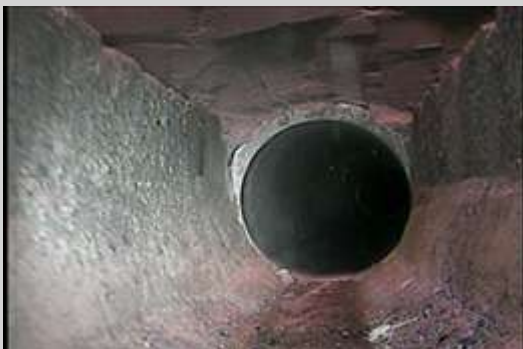
8 in. Circular Gravity Sewer Pipe In @ 6 O'Clock

Pipe Material: **Clay** ☐ Pipe Lined

Infiltration: **None** Pipe Seal Cond: **Unknown**
